NAVAL POSTGRADUATE SCHOOL

THESIS

INVESTIGATION INTO THE EFFECT OF
DISSIMILAR METAL COUPLING, POTENTIAL, AND PROCESSING
ON THE MODE AND DISTRIBUTION
OF GALVANIC CORROSION ATTACK ON 5086 ALUMINUM ALLOY
IN SYNTHETIC SEAWATER

September 1977

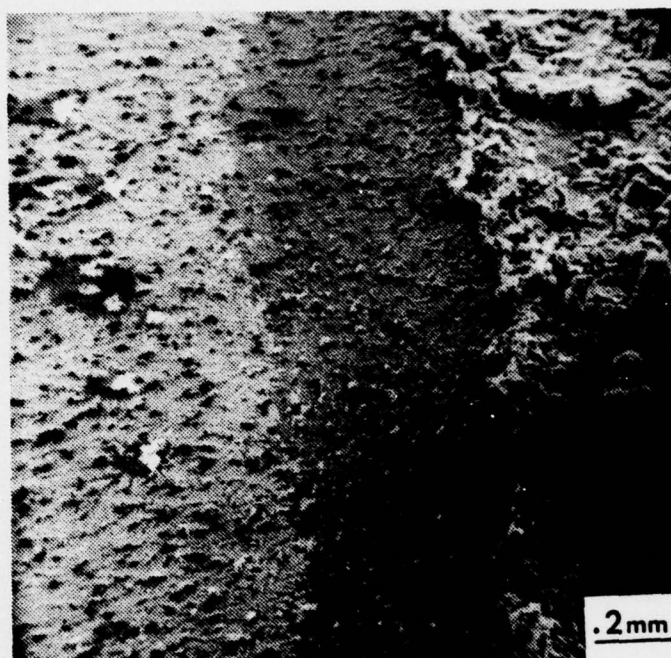
Figure 32. Precipitate formation on steel in Steel/H32 couple exposed for three weeks, (a) 55X (SEM), (b) 105X (SEM).

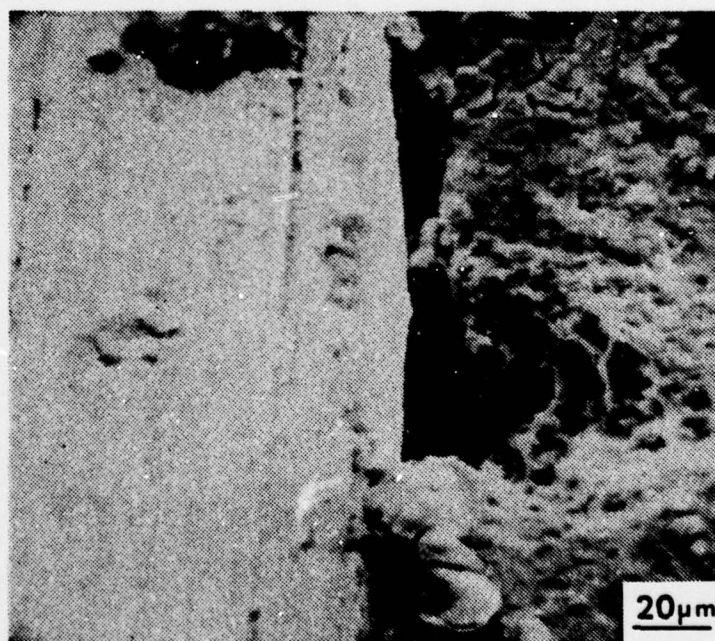
Figure 55. (a) TI/H32 couple exposed for two weeks, 22X (SEM)
(b) Brass/H32 couple exposed for eight weeks, 550X (SEM)
